THE RUBAS FORTIFICATION OF THE MID-SIXTH CENTURY: STRUCTURAL FEATURES OF THE WESTERN FACADE OF WALL 2

Abstract. The Rubas Fortification is a complex of stone military-engineering structures, uncovered in 2014 in the lower reaches of the Rubas River, 20 km south-west of Derbent, near the village of Kommuna, Derbent district of the Republic of Dagestan. According to its functional purpose, this archaeological site belongs to a series of monumental defensive structures erected in the Caspian Passage (Eastern Caucasus) by the Sassanid Iran with the financial aid of Byzantium in the 5–6th centuries, and preventing nomadic tribes from raids in the countries of Transcaucasia and the Middle East. Typologically and chronologically (6th century), the Rubas defensive complex is similar to the stone fortifications of Derbent. Excavations in 2014, 2016–2018, 2020 on a compact section of the left bank of the Rubas River with an area of 300 sq.m. revealed six separate military-engineering structures connected to each other by construction joints. The central position of this complex is occupied by the main Wall 2, oriented in the meridian direction (NW–SE). It has been uncovered for 28 m, is in

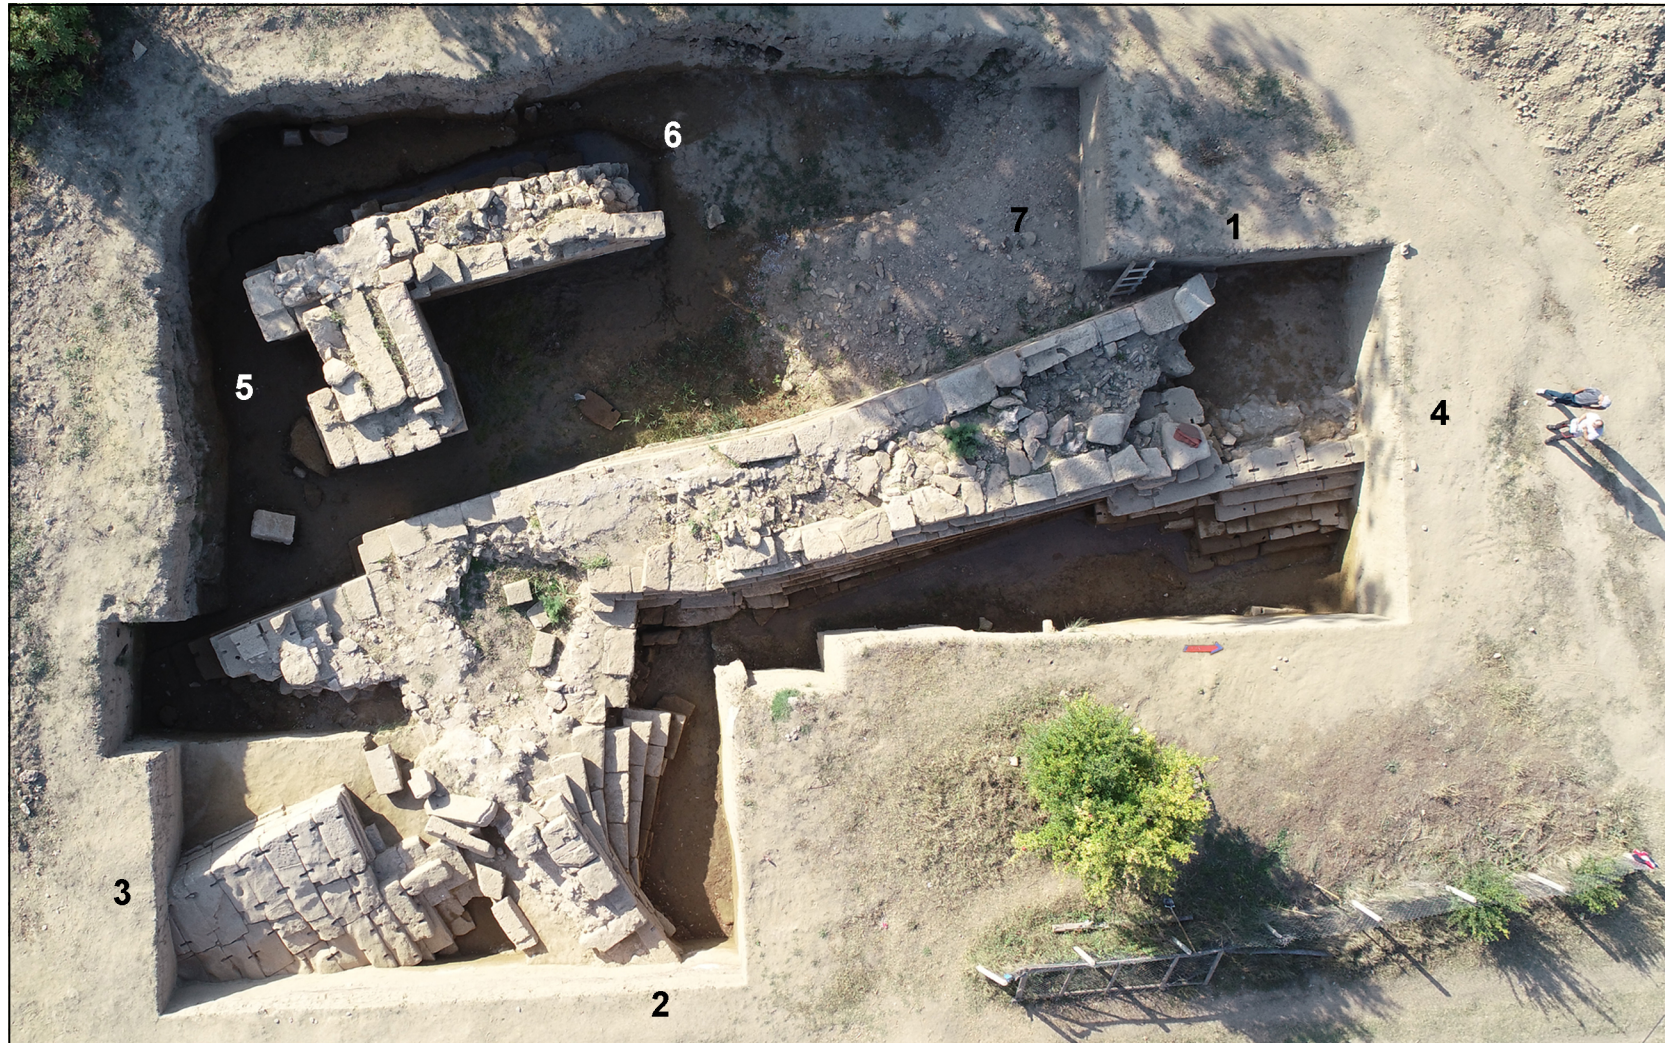
Fig. 1. The Rubas Fortification of the 6th c. 1 – Wall 2; 2 – Wall 3; 3 – Structure 5 (Platform); 4 – Structure 6 (Extension); 5 – Arched Structure; 6 – Wall 1; 7 – mudflow deposits. View from the north. Drone photography, 2020

Currently, six military-engineering structures have been explored: 1) Main Wall 2 (oriented NW–SE); 2) round-shaped Wall 3, built into the eastern facade of Wall 2 on the southern section (orientation W–NE); 3) stepped Structure 6, attached to the eastern facade of Wall 2 from the north (orientation along the long side of NW–SE); 4) Structure 5 in the form of a platform located to the south of Wall 3 (orientation by the location of elongated blocks of the NEE–SWW); 5) arched structure (reinforced entrance to the site) located to the west of Wall 2 (orientation along the long side of SWW–NEE); 6) Wall 1, attached from the north side to the construction of the arched structure (orientation NW–SE) [Fig. 1, 1–6; 2, 1–4, 6–7][1, pp. 912–937].

Most of the structures of the Rubas fortification have been preserved at a height of 2–2.5 m due to natural conservation by mudflow deposits. The identified structures are distinguished by their individual layout and design, as well as the building materials used [Fig. 1, 1–6; 2, 1–4, 6–7].

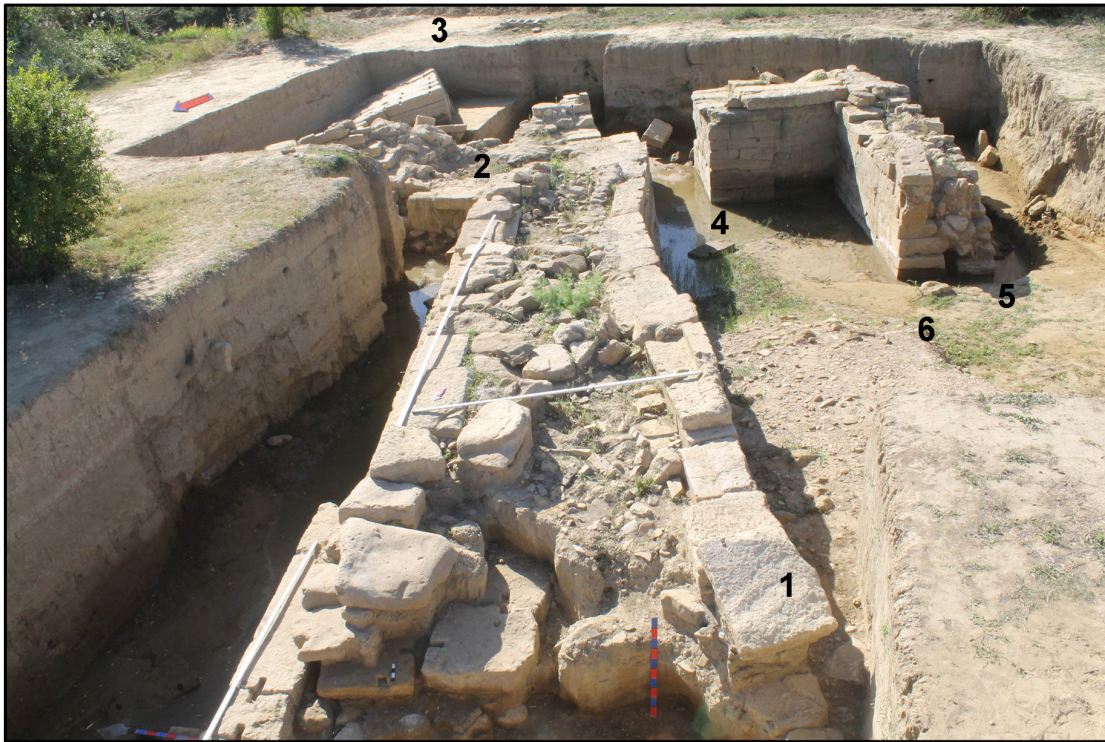
Fig. 3. The Rubas Fortification of the 6th c. 1 – Wall 2; 2 – Wall 3; 3 – Structure 5 (Platform); 4 – Arched Structure; 5 – Wall 1; 6 – mudflow deposits. View from the north. Photo of 2020

The width (thickness) of Wall 2 varies. On the southern section, at the place where Wall 3 adjoins it, it is 2.7 m. At the northern end, the width of Wall 2 increases to 3.3 m [Fig. 2, 1]. The difference in the parameters of the wall's width may possibly be caused by seismic activity [2, p. 91–103]. The shape of Wall 2 is distorted, which can be clearly seen on the western facade. In the central part, the facade has a concavity directed to the east; the northern and southern ends of the facade, on the contrary, have a bulge directed to the west [Fig. 2, 1; 3, 1; 4, 1].

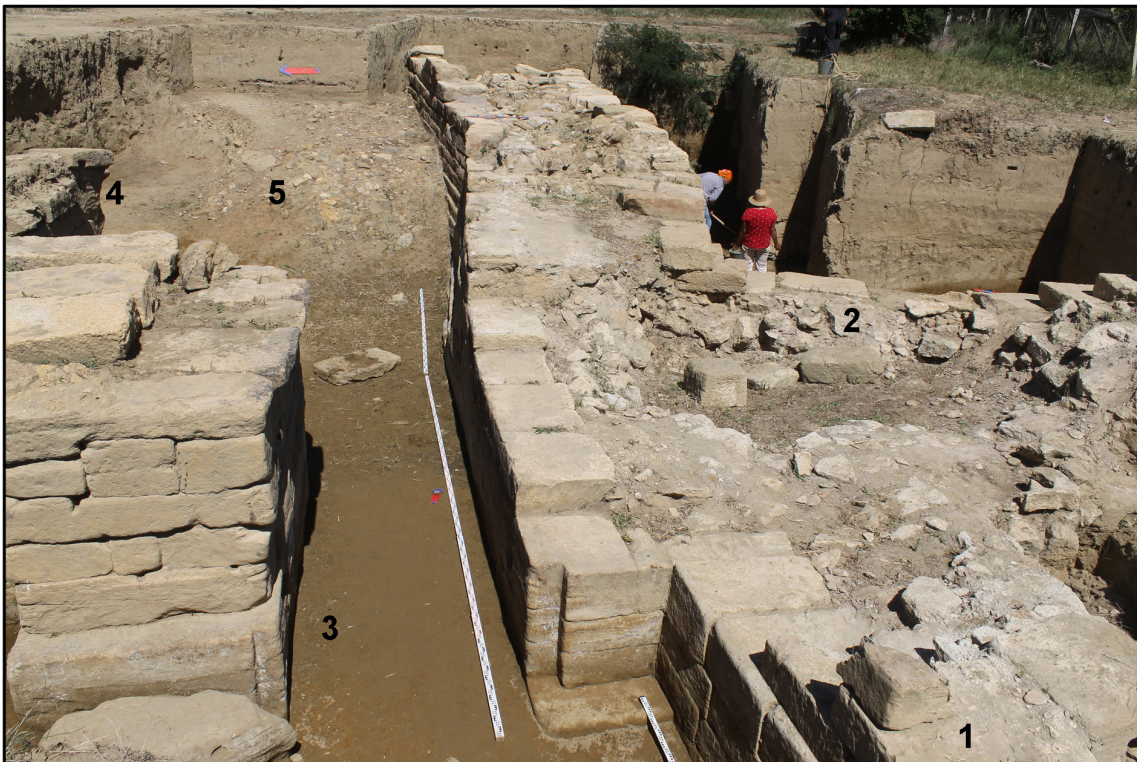
Fig. 4. The Rubas Fortification of the 6th c. 1 – Wall 2; 2 – Wall 3; 3 – Arched Structure; 4 – Wall 1; 5 – mudflow deposits. View from the south. Photo of 2020

Structurally, Section C' consists of two parts – the northern and southern ones, since the southern segment is shifted to the east relative to the northern one by 0.8 m [Fig. 1, 1; 2, 1; 4, 1; 5, 1; 9; 15]. This design is caused by the need for the erection of defense elements in the form of metal gratings, for the dumping and lifting of which it was necessary to construct gutters and ensure the indentation of the section of the western facade from the general line by 0.8 m to the east [Fig. 4, 1, 3].

As noted, at the end sections of Blocks 39, 117, 126 there were sockets with a width of 0.22 m, designed for lowering and lifting metal gratings, also used to lock the passage between the eastern facade of Base-support 1 and the western facade of Wall 2 [Fig. 2, 1; 4, 1] [2, pp. 477–478].

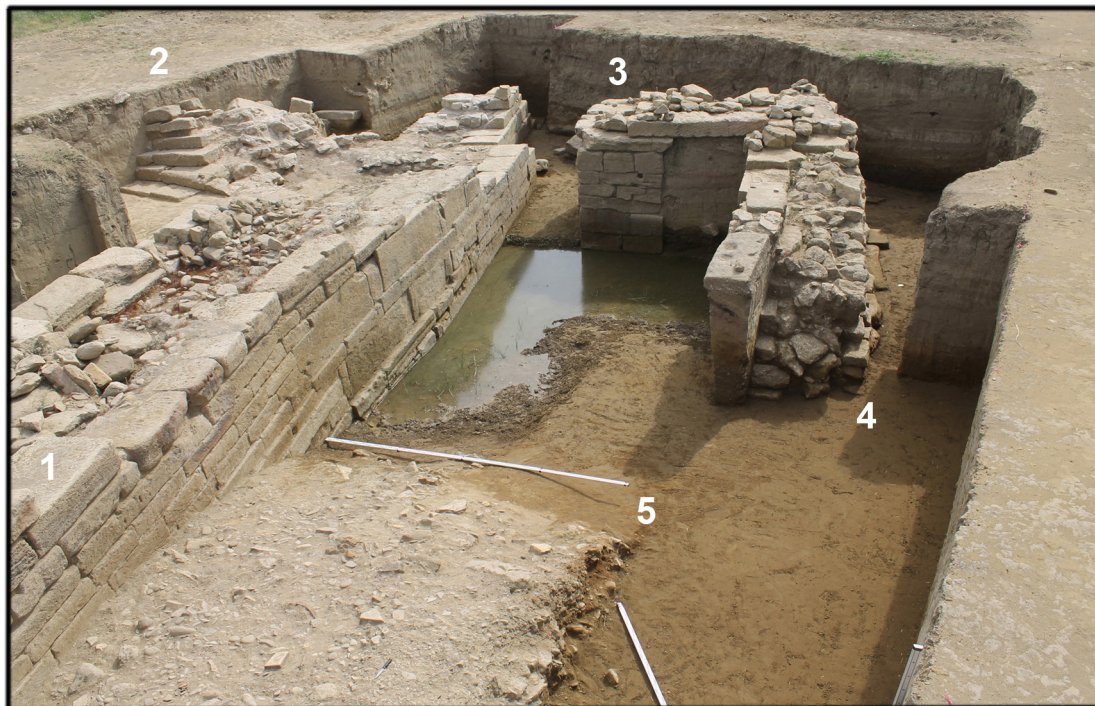
Fig. 5. The Rubas Fortification of the 6th c. 1 – Wall 2, western facade; 2 – Wall 3; 3 – Arched Structure; 4 – Wall 1; 5 – mudflow deposits. View from the north. Photo of 2018

The main difference between the western facade of Wall 2 and its eastern facade is the absence of a stepped structure in it. The western facade throughout its whole length has practically smooth surface with well-fitted to each other stone blocks and, in all likeliness, the use of mortar in the places of bond of stone blocks [Fig. 5–10].

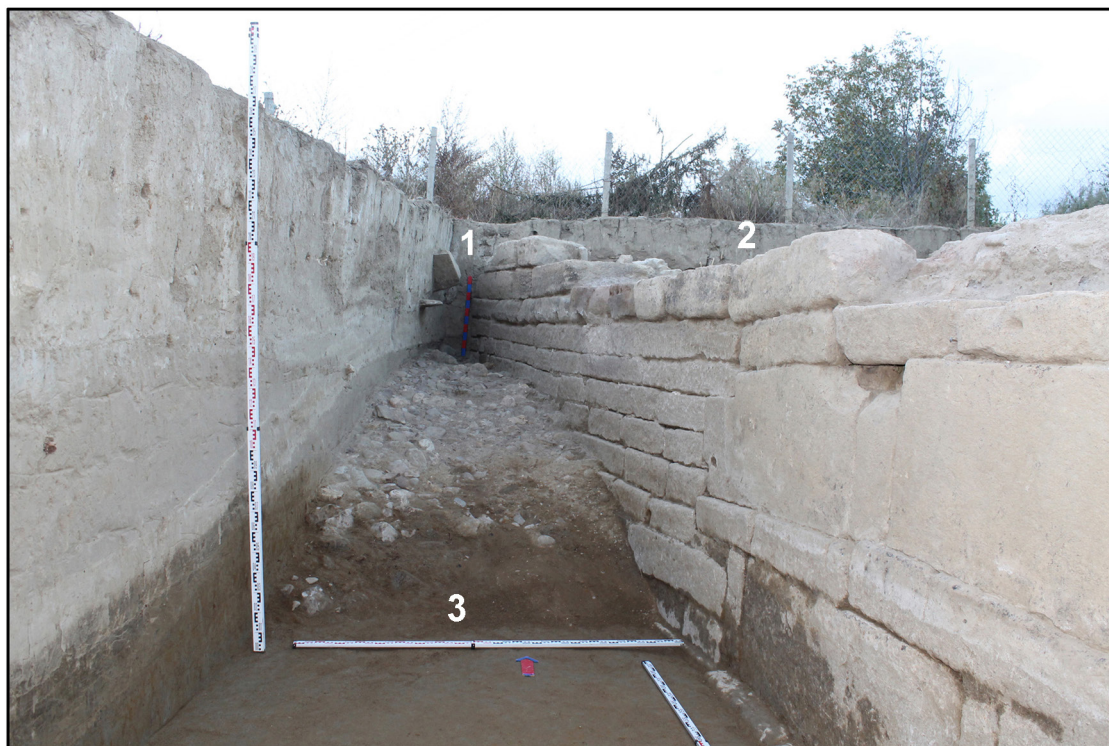
Fig. 6. The Rubas Fortification of the 6th c. 1 – Wall 2, western facade, northern section; 2 – Wall 2, western facade, central section; 3 – mudflow deposits. View from the south. Photo of 2017

Section A' was explored in 2016-2018. The section is located at the northern end of the western facade of Wall 2. The length is 9.0 m [Fig. 6, 1; 12, A'; 13]. Pebble stone debris of a mudflow with a maximum thickness of 1.5 m adjoins this section of the facade [Fig. 11; 12; 13]. The head section of the mudflow is located at the southern end of this section of the western facade [Fig. 1, 7; 2, 5; 3, 6; 4, 5; 5, 5; 6, 3].

Section B' was explored in 2016-2018, 2020. It is located in the central part of the western facade of Wall 2. The length of the section is 5.7 m. This section is built into the southern end of Section A' [Fig. 6, 2; 7-8; 9, 1; 14].

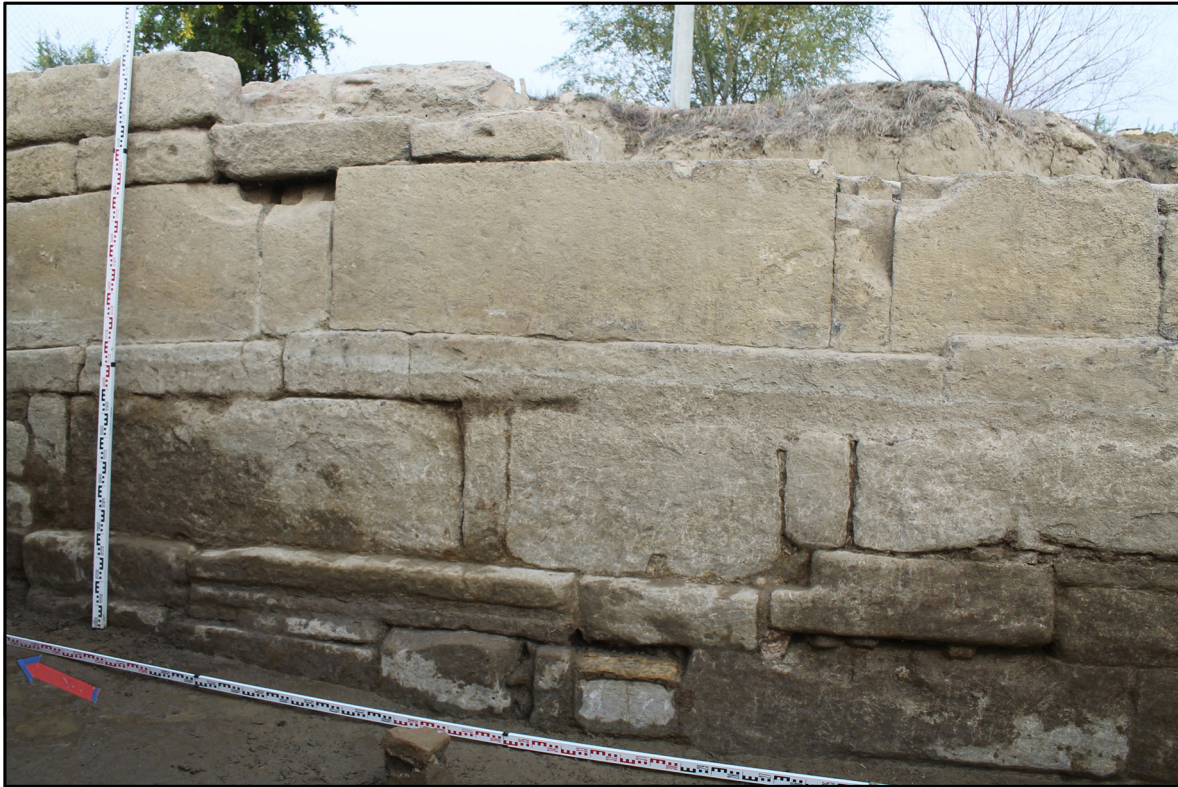
Fig. 7. The Rubas Fortification of the 6th c. Wall 2. Western facade. Central section. View from the west. Photo 2017

The masonry of Section B', installed according to the “opus quadratum” system, consisted of 6 header and 6 stretcher blocks. The stretcher blocks are laid vertically on a long side (Blocks 21, 23, 25, 28, 91, 93). The header blocks are installed with their long sides outwards (Blocks 22, 24, 26, 90, 92, 102) [Fig. 6-8; 9, 1; 14].

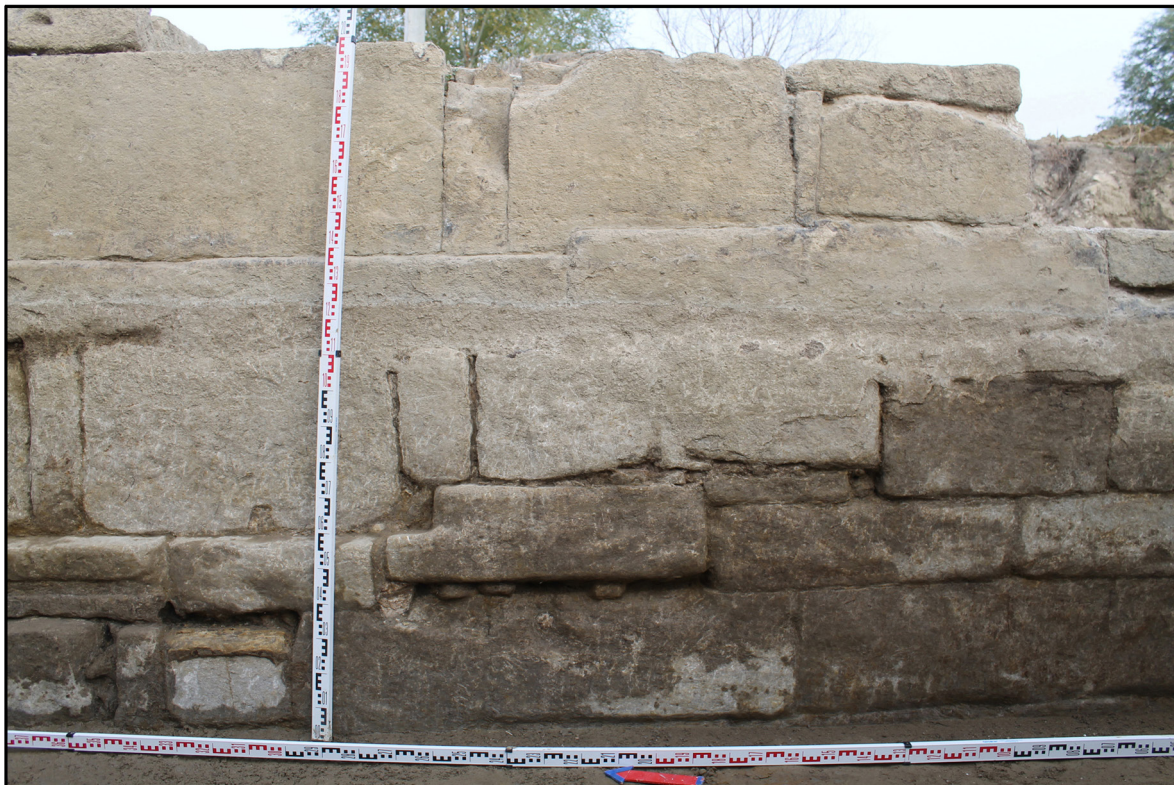
Fig. 8. The Rubas Fortification of the 6th c. Wall 2. Western facade. Central section. View from the west. Photo 2017

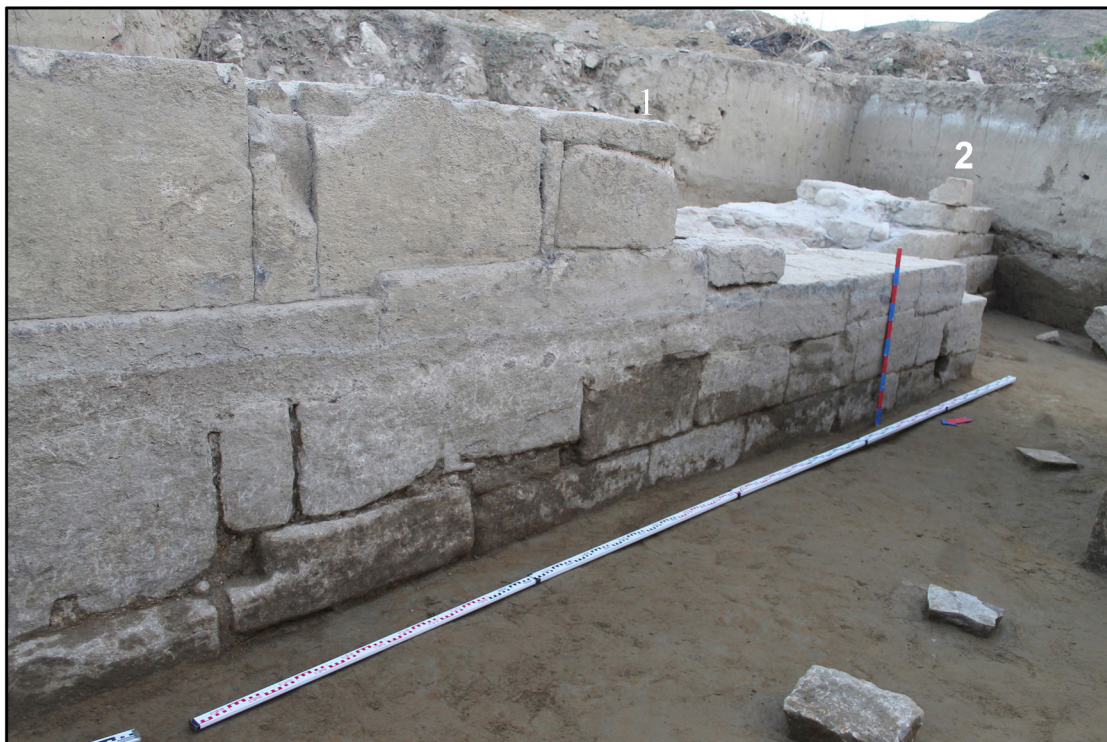
Fig. 9. The Rubas Fortification of the 6th c. 1 – Wall 2, western facade, central section; 2 – Wall 2, western facade, southern section. View from the northwest. Photo of 2017

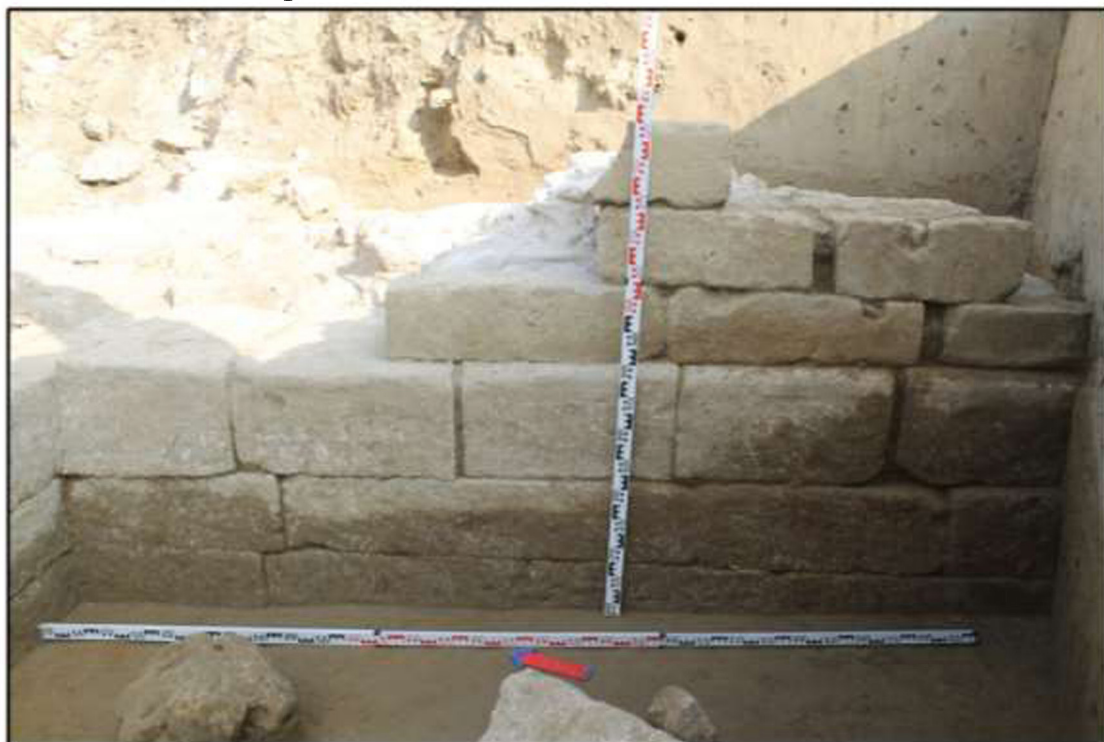
Fig. 10. The Rubas Fortification of the 6th c. Wall 2. Western facade. Southern section. View from the west. Photo 2017

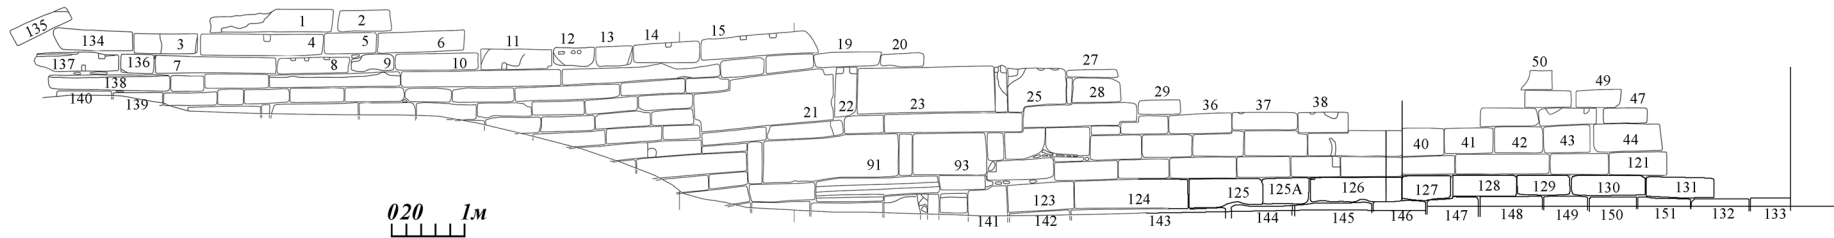
Fig. 11. The Rubas Fortification of the 6th c.
Wall 2. Western facade. 2020

The western facade of Wall 2 has no extensions. According to the 2018 excavations, its southern end has a continuation to the south towards the left bank of the Rubas River. Its northern end breaks 4 m from the northern side of the excavation area of 2018. The total length of the revealed part of the western facade for the period of 2018 is 23.8 m [Fig. 2.1; 11; 12].

The structure of the western facade of Wall 2 is also heterogeneous [Fig. 11]. There are 3 distinctive sections in it, varying in structure and building technology (sections A', B', C') [Fig. 12, A', B', C']. Various construction techniques were applied in the places of bonding. The structural features of these sites are due to the functional orientation of each of them. The objectivity of the conclusions on each of the sections of the western facade of Wall 2 implies a complete description of the available database (a number of blocks preserved on the site, their dimensions, features of their bonding in the masonry, a system of bonding of various blocks between the sections, etc.).

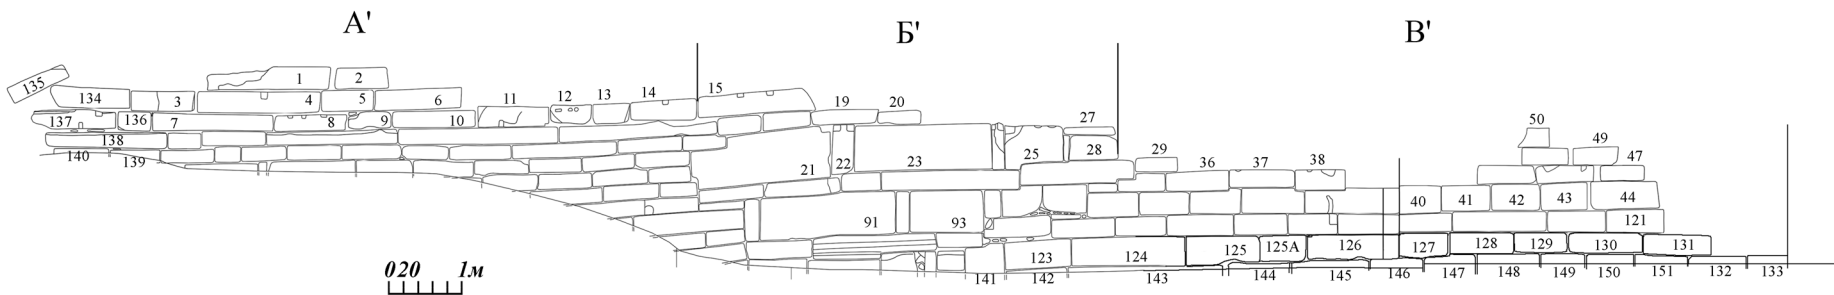
Fig. 12. The Rubas Fortification of the 6th c.
Wall 2. Western facade. A', B', C' – architectural sections. 2020. Published for the first time

Three sections with different types of masonry in the structure of the western facade of Wall 2 visually stand out: northern (running bond masonry of elongated blocks of medium thickness); central (alternating layers of “opus quadratum” masonry with single-row running bond masonry); southern (running bond of thickened blocks) [Fig. 12, A', B', C'].

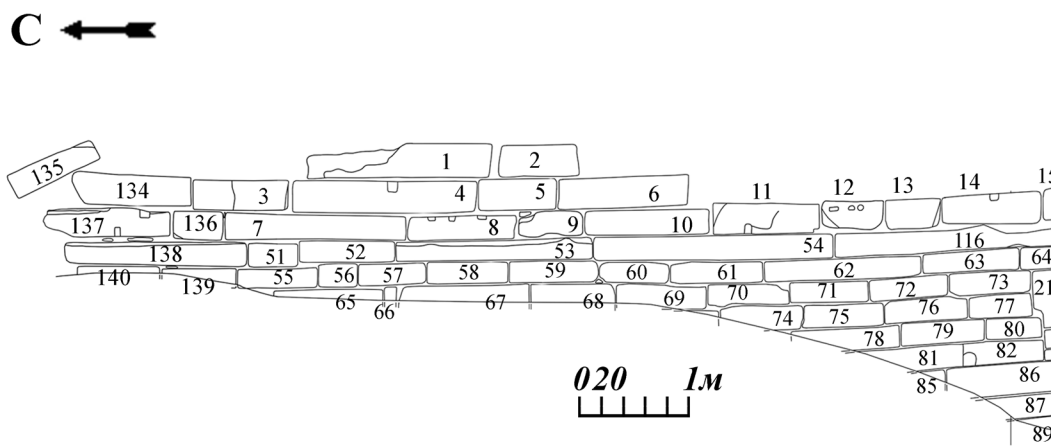
Fig. 13. The Rubas Fortification of the 6th c. Wall 2. Western facade. Northern section

At the northern end of Section A', no traces of mudslide deposits on the three upper full rows of masonry and the lower incomplete row (Blocks 134, 136-140) were recorded. The height of the northern end of this section is 0.94 m [Fig. 13].

Ten rows of masonry (Blocks 14, 16, 63-64, 73, 77, 80, 83, 84-89) and 1 incomplete row (without No.) were revealed at the southern end of Section A' [Fig. 13]. The height of the southern end of Section A' is 2.3 m.

The uncovered level of Section A' comprises 62 blocks: Blocks 1-14, 16, 51-89, 134-140. The first (upper) row consists of 2 blocks (1-2), the second row - of 6 blocks (134-135, 3-6), the third row - of 10 blocks (137, 136, 7-14), the fourth row - of 6 blocks (138, 51-54, 16), the fifth row - of 12 blocks (140, 139, 55-64), the sixth row - of 9 blocks (65-73), the seventh row - of 4 blocks (74-77), the eighth row - of 3 blocks (78-80), the ninth row - of 4 blocks (81-84), the tenth row - of 2 blocks (85, 86), the eleventh row - of 2 blocks (87-88), the twelfth row included 1 block (89), the thirteenth row also included 1 block (without No.) [Fig. 13].

The masonry of Section A' comprises 7 large blocks (Nos. 1, 4, 7, 16, 53-54, 138). They are installed in rows 1-4 of the masonry. Large Block 1 of the first row of masonry has dimensions of 1.66×0.3 m. Large Block 4 of the second row - 1,7×0,3 m. Large Block 7 of the third row - 1.66×0.24 m. The fourth row had 4 large blocks - Block 138 (1.66×0.2 m), Block 53 (2.0×0.14 m), Block 54 (2.2×0.2 m) and Block 16 (2.16×0.2 m) [Fig. 13].

The blocks of Section A' of the western facade of Wall 2 are finely dressed, installed without ledges. However, in the masonry we found some blocks of secondary use. In the 1st row, on the surface of Large Block 1 with a length of 1.6 m, there was a nonextant architectural detail at the northern end. One of the longest Blocks 16 is installed in the 4th row. Its upper level had defects with pointed protrusions in the southern half. The irregularities of Block 16 were smoothed with a layer of mortar to install Block 14 of the third row of masonry on it. The surface of Block 53 with a length of 2.0 m of the fourth row of masonry was also uneven. It was also smoothed with mortar [Fig. 13].

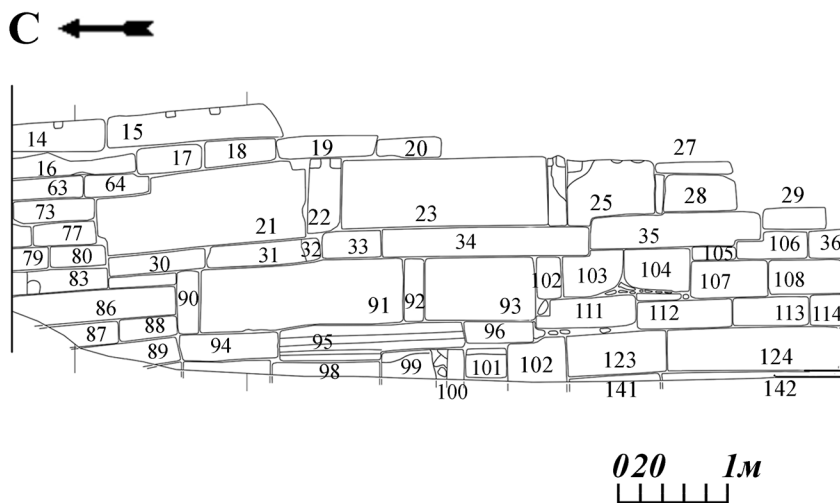
Fig. 14. The Rubas Fortification of the 6th c. Wall 2. Western facade. Central section

The structure of Section B' is laid with two types of masonry – running bond and “opus quadratum”. The running bond masonry served as inter-layers and overlaps between two rows of “opus quadratum” masonry [Fig. 14].

The first and second rows of masonry are laid in a running bond (Blocks 15, 17–20), the third row – in the “opus quadratum” technique (Blocks 21–28), the fourth row – in the running bond (Blocks 30–35), the fifth row – in the “opus quadratum” technique (Blocks 90–93), the sixth and the seventh row of masonry – in a running bond (Blocks 94–102) [Fig. 14].

The uncovered level of Section B' comprises 32 blocks: Blocks 15, 17–28, 30–35, 90–102. In the first row, one block (No. 15) is installed in a running bond method. The second row comprises 4 blocks (Nos. 17–20), which are also installed in a running bond. The third row consists of 8 blocks (Nos. 21–28) installed according to the “opus quadratum” technique. The fourth row comprises 6 blocks (Nos. 30–35) installed in a running bond. The fifth row consists of 5 blocks installed according to the “opus quadratum” technique (Nos. 90–94), supplemented by two rows of blocks installed in a running bond (No. 102–105, 111–112). The sixth and seventh rows include 8 blocks installed in a running bond (Nos. 94–102) [Fig. 14].

The height of the header blocks corresponds mainly to the width of the stretcher blocks, next to which they were installed: Block 22 (height 0.68 m, thickness 0.3 m), Block 24 (height 0.62 m, thickness 0.18 m), Block 90 (height 0.6 m, thickness 0.2 m), Block 92 (height 0.6 m, thickness 0.2 m). The exception is the header Block 26, installed between the stretcher Blocks 25 and 28, which have different widths at the place of its installation. The header Block 26 has a height equal to the width of the stretcher Block 28. The missing height level, which corresponds to the width of Block 25, was increased by laying Block 27 on the upper level of Blocks 26 and 28, with the following parameters: length 0.7 m, thickness 0.1 m [Fig. 14].

of the height of the side of the block, installed on a long edge. Thus, the header Block 90 is bonded with a masonry comprising three blocks (Nos. 84, 86, 88), according to the total height corresponding to the height of the header Block 90 [Fig. 13–14]. Section B' consists of 3 large stretcher blocks with a length of 1.9 m, (Blocks 21 and 23) and 1.82 m (Block 91), respectively. Among the blocks, installed in a running bond, there are 3 large blocks – Block 34 (1.9 m long), Block 35 (1.56 m long), Block 95 (1.7 m long), Block 15 (1.6 m long) [Fig. 14].

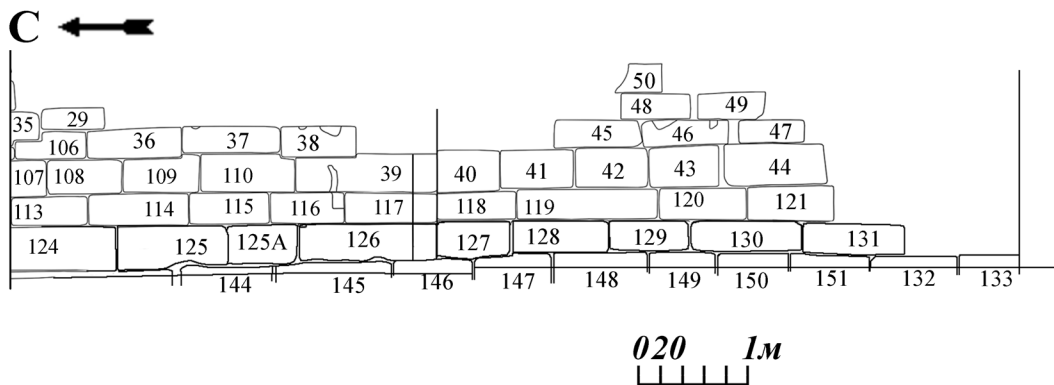
Рис. 15. Рубаский оборонительный комплекс сер. VI. Стена №2. Западный фасад. Южный участок

The northern part of Section C' comprises 26 stone blocks. Only 5 rows of masonry and the upper level of the lower row have survived. As noted, all rows of the masonry are laid in a running bond. The height of the northern end of this part of the section is 1.54 m, the height of northern end is 1.1 m. The length along the upper level of the facade is 3.8 m. This section of Wall 2 sustained the most significant damage in 2014. Here, the upper level of the masonry of the western facade with a total height of 0.5 m was dismantled [Fig. 15].

Technical recesses on the outer surfaces of some blocks of the northern part of Section C' were recorded. Block 116 (4th row of masonry) has a recess (indent, or socket) of a quadrangular shape with a size of 0.15×0.09 m at a depth of 0.1 m, in which a wooden bar for locking the bi-fold gate was fixed. A similar socket of a slightly different shape was found at the same level on the eastern facade of Base-support 1 of the arched structure. The wooden bar-lock was first inserted by sliding it into the socket of Block 116. From the constant sliding of the bar to Block 116, a deep curved dent formed on top of Block 39. A similar dent was revealed on the upper block of the eastern facade of Base-support 1 [Fig. 15].

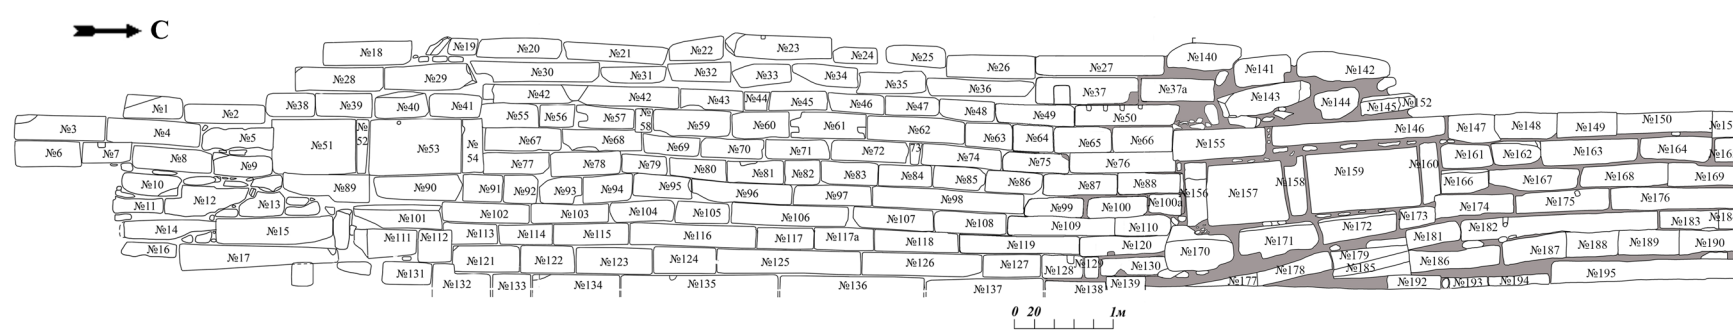
Fig. 16. The Rubas Fortification of the 6th c.
Wall 2. Eastern facade

As noted, the analysis of the structure of the eastern facade of Wall 2 revealed 5 construction sections in it (sites A, B, C, D, E). Section C was built in a running bond masonry (also called stretcher bond, ashlar fine bond, *opus isodomum*) in a stepped manner. Sections B and D are built with the use of two technologies – alternation of “opus quadratum” and a running bond stepped structure. Sections A and E are built with the application of running bond masonry using wide steps [Fig. 16; 17] [1, pp. 916–919].

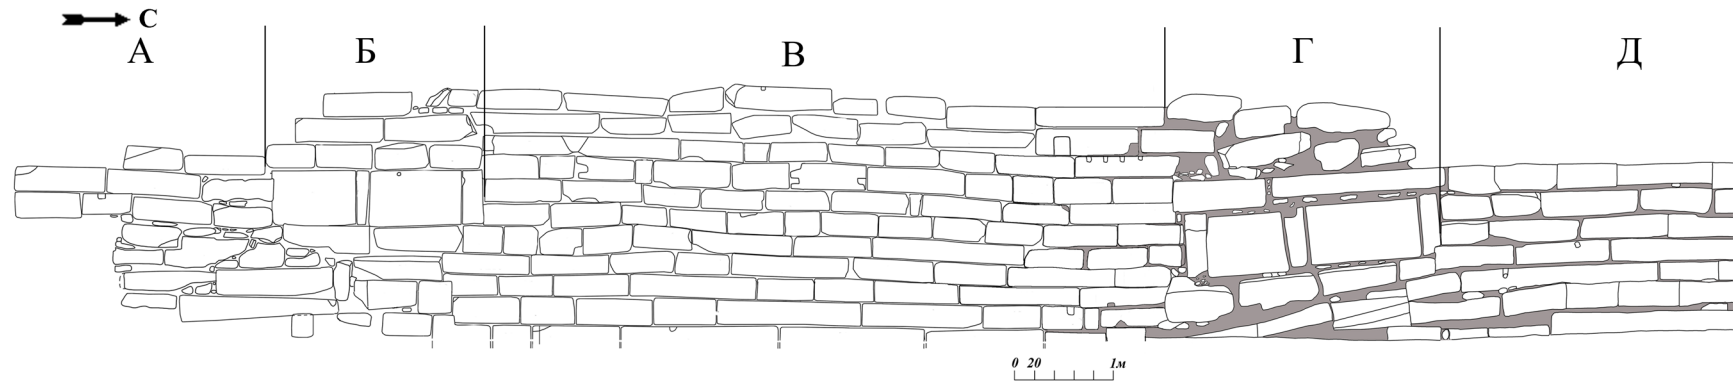
Fig. 17. The Rubas Fortification of the 6th c.
Wall 2. Eastern facade. A, B, C, D, E – architectural details

The analysis of the structure of the eastern facade of Wall 2 has revealed the presence of 5 distinctive sections varying in the masonry and construction types (sections A, B, C, D, E) [Fig. 17, A, B, C, D, E] [1, pp. 916–918].

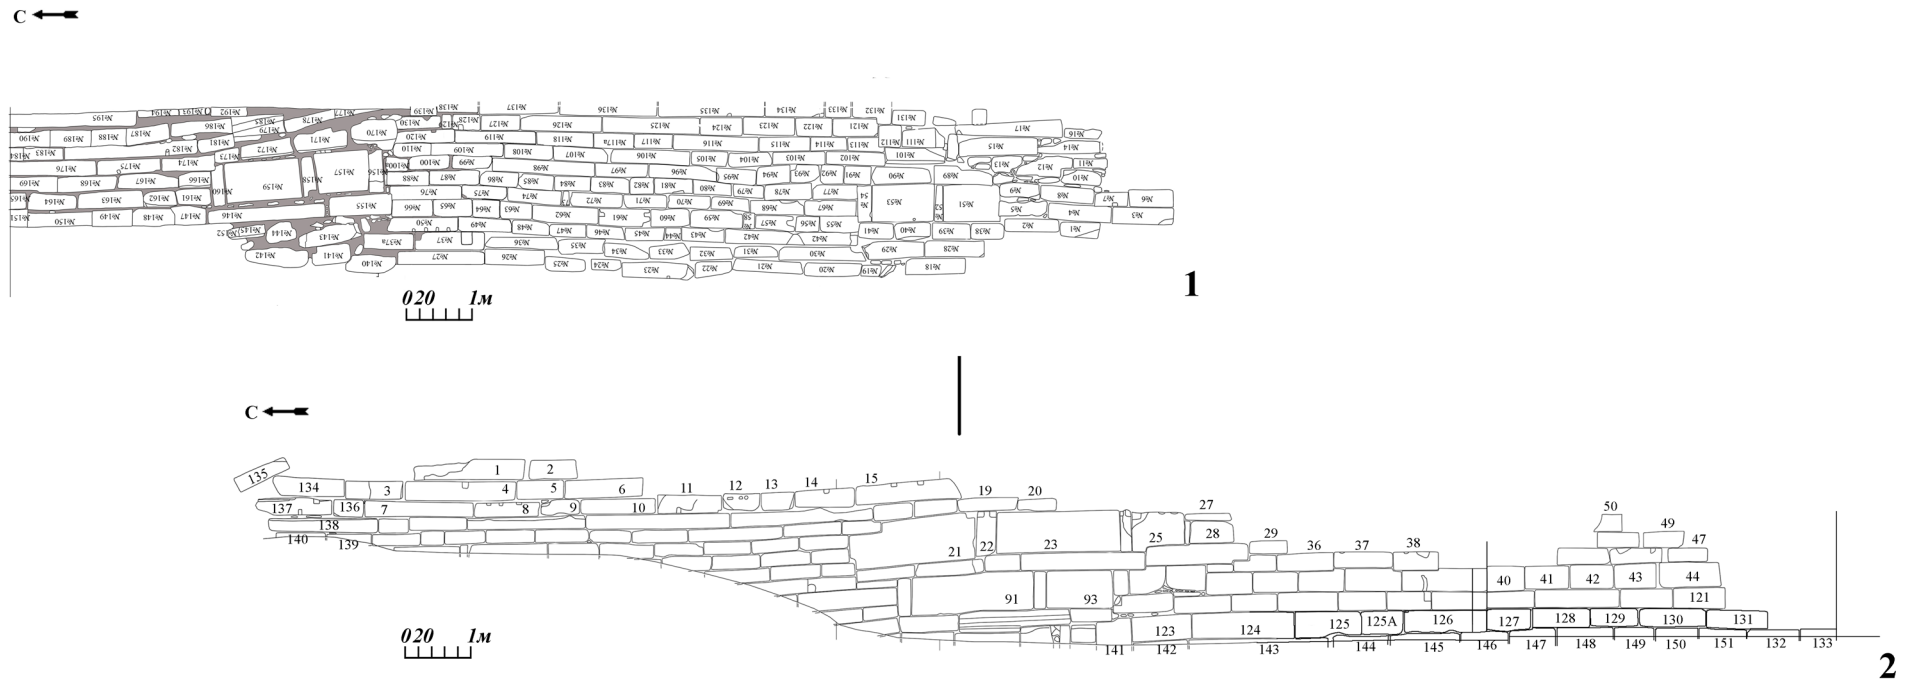
Fig. 18. The Rubas Fortification of the 6th c. Wall 2.
Combined facades. 1 – eastern facade; 2 – western facade
