ISSUES OF INTERPRETATION OF THE EARLY MEDIEVAL COMPLEX OF ENGINEERING STRUCTURES ON THE RUBAS RIVER (EASTERN CAUCASUS): A FORTIFICATION OR HYDRAULIC STRUCTURE?

Abstract. The article presents new data on the functional purpose of a complex of engineering structures from the Early Middle Ages discovered in the valley of the river Rubas, located 20 km south of the city of Derbent. Excavations revealed six separate architectural objects interconnected by structural links. These objects were erected using large, finely crafted stone blocks and featured unique designs employing various construction techniques. Our initial interpretation of these engineering structures identified them as a military-technical facility with a defensive orientation. Chronologically, it was dated to the mid-6th century, considering the resemblance in construction technology to the Sasanian defensive complex in Derbent. However, additional data were uncovered, suggesting an alternative functional purpose – specifically, a hydraulic structure. Based on written sources, the construction date has been established (790-797), and the object's purpose has been determined. The purpose of this article is to substanti

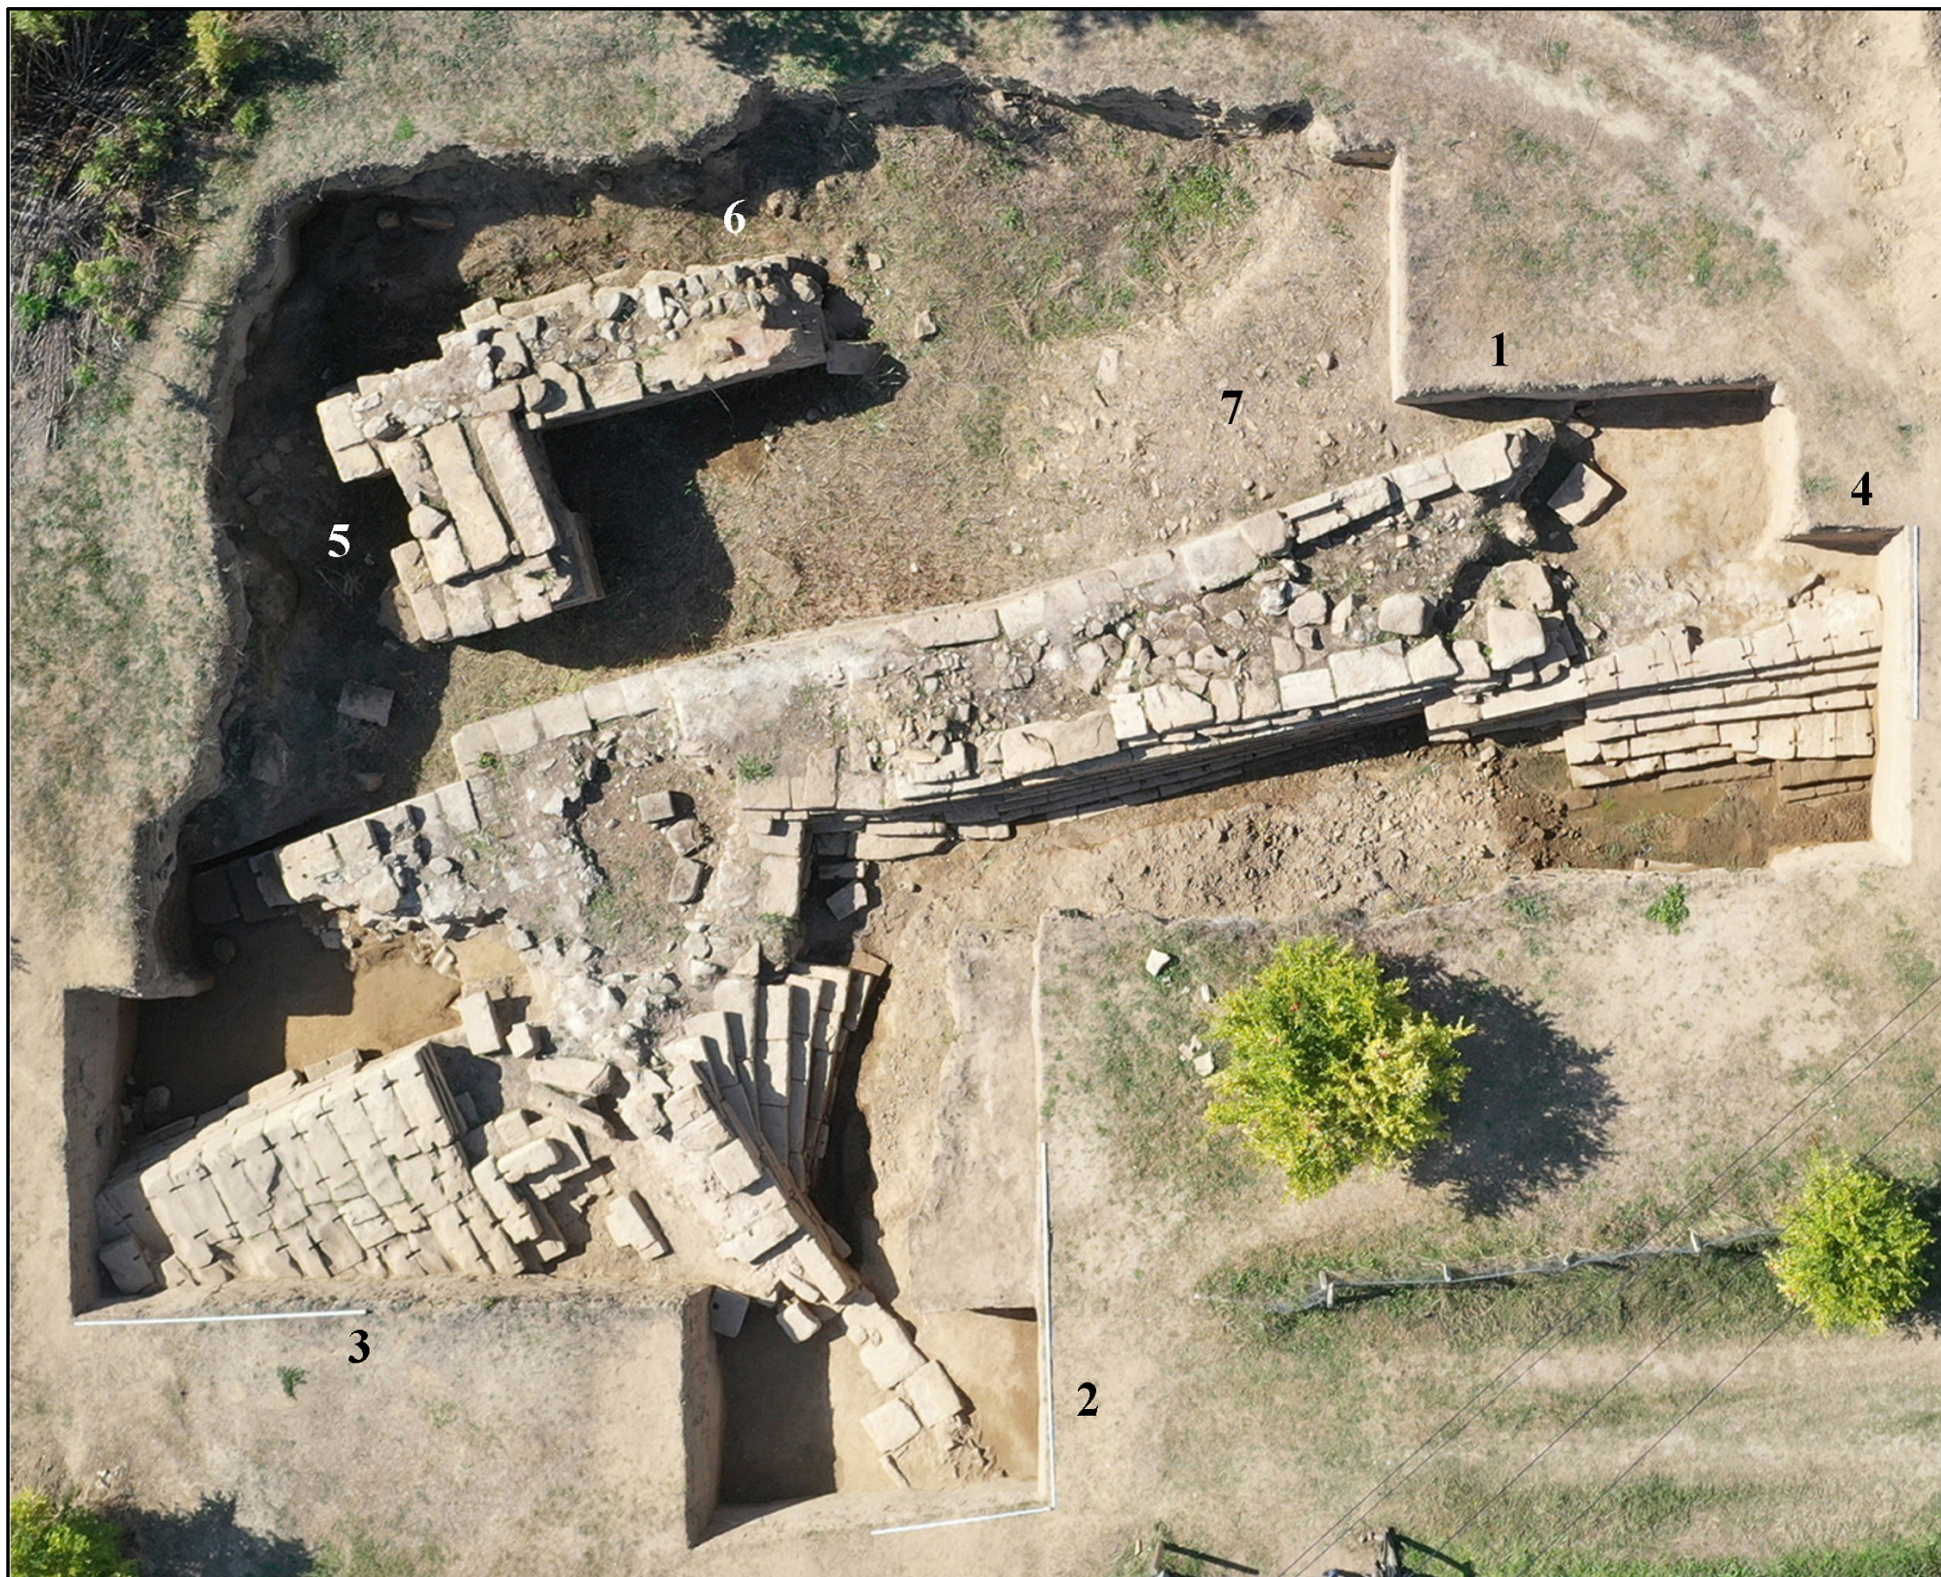
Fig. 1. Monumental architectural structure on river Rubas.
1 – Wall No. 2; 2 – Wall No. 3; 3 – Structure No. 5 (Platform); 4 – Structure No. 6 (Extension); 5 – Arched Structure; 6 – Wall No. 1;
7 – mudflow deposits. View from east. Aerial drone shot, 2022

A 2.2 m long section of the eastern facade of Wall No. 2 was uncovered, revealing 9 rows of regular masonry arranged in stepped manner, reaching a height of 2.3 m. The orientation of the wall is S–N, perpendicular to the riverbed of Rubas (Fig. 1, 1; 2, 1). The southern limit of the eastern facade of Wall No. 2 was defined by a section of the upper level of Wall No. 3, measuring 3.0 m in length within the pit and oriented in the W–E direction (Fig. 1, 2; 2, 4). West of the pit, exploration of the upper level of the arched structure revealed two massive support bases, designated as Nos. 1–2. The passage between these bases (arch) was 1.5 m wide and covered at the top by three stone slabs measuring 2.3–2.5 m in length. This structure was aligned with its longitudinal side in the W–E direction (Fig. 1, 5; 2, 2). Support Base No. 2, situated west of Support Base No. 1, was adjacent on the north side to a section of Wall No. 1, oriented in the S–N direction (Fig. 1, 6; 2, 3).

1. **Arched Structure** (Fig. 1, 5; 2, 2). Design: two rectangular Support Bases Nos. 1–2 (3.0×1.5 m), with a passage between them (1.5 m), covered by massive slabs (2.4–2.6 m in length). The structure is oriented along its length in the W–E direction. Seven rows of masonry, laid from massive blocks (2.3–2.4 m high), were cleared (Fig. 6).

2. **Wall No. 1** (Fig. 1, 6; 2, 3). Design: emplekton¹ (eastern facade) and rubblework (western facade) with inner backfill (1.9 m in thickness). Attached from the north to Support Base No. 2 of the arched structure. Orientation N–S. Seven rows of rubble masonry were exposed, reaching a height of 2.3 m. The length of Wall No. 1 is 5.3 m. Notably, different technologies were employed in the construction of its eastern and western facades.

3. **Wall No. 2** (Fig. 1, 1; 2, 1). Design: emplekton and inner backfill (3.5 m in thickness). A 28 m section was cleared, with NW–SE orientation. Technology: the western facade exhibits a combination of extended sections of stretcher masonry and *opus quadratum* (Fig. 4). The eastern facade is constructed with stepped stretcher masonry, including a small area with *opus quadratum* (Fig. 3, 1). The western facade was cleared to a height of 2.5 m (11 rows of masonry), while the eastern facade reached a height of 2.6 m (11 rows of masonry) (Fig. 3–4).

4. **Wall No. 3** (Fig. 1, 2; 2, 4). Design: combined, featuring a section of stretcher rectilinear masonry with a length of 8.2 m and a stepped structure of a rounded (concave) shape with a length of 4.1 m attached to it from the north. The wall stands at a height of 2.4 m (10 rows of masonry). The orientation of the straight section of the wall is NE–SW, and is attached to the eastern facade of Wall No. 2.

5. **Structure No. 5 (Platform)** (Fig. 1, 3; 2, 6). Design: header-stretcher (Flemish) masonry, with 6 identified levels made of rectangular stone blocks. Over 8.0 m was cleared (Fig. 5). The surface level comprises 15 vertical rows, and the stone blocks are equipped with grooves for installing fastening brackets. The western facade was cleared to a height of 1.94 m (Fig. 5). The platform slopes east at an angle of 22.5°. No link systems with other

6. **Structure No. 6** (Fig. 1, 4; 2, 7). Design: stepped stretcher masonry, incorporating a section of *opus quadratum*. Attached from the north to the eastern facade of Wall No. 2. The orientation is NW–SE. The cleared section measures 7.7 m in length (Fig. 3, 2) and includes northern and southern sections with differing parameters and designs (5.0 m and 2.7 m, respectively). The state of preservation of the northern section: height of 1.64 m and 7 levels of masonry. The state of preservation of southern section: height of 2.44 m (Fig. 3, 2). It extends beyond the baseline of the eastern facade of Wall No. 2 of the upper level of the masonry by 2.6 m.

These data may suggest a different functional purpose for these passages, potentially serving as drainage channels to discharge water accumulated in a confined space enclosed on three sides by construction objects (Wall No. 1, Arched Structure, Wall No. 2) (Fig. 1, 1, 5, 6; 2, 1, 2, 3).

3. It is also conceivable that the space between Wall No. 1 and Wall No. 2 functioned as a water storage tank, akin to a reservoir (Fig. 1–2). In such a scenario, Wall No. 2 would have likely served as a dam, being the longest and most robust structure in this complex with a thickness of 3.5 m. However, it's worth noting that in regions where historical remnants of irrigation structures are observed, such as Southeast Asia, dams typically exhibit greater thickness.

However, the thickness of the section of sedimentary rocks within the Rubas architectural complex (Fig. 1, 7; 2, 5) offers insights into the duration of its accumulation. Assuming an annual sediment accumulation rate of 1.0 cm, the estimated period for the formation of the sedimentary section at the Rubas site (1.5 m thick) spans approximately 150 years. This implies that the operation of the irrigation complex likely continued until around 940. It is plausible that the facility suffered significant damage from a magnitude 9 earthquake, leading to its abandonment.

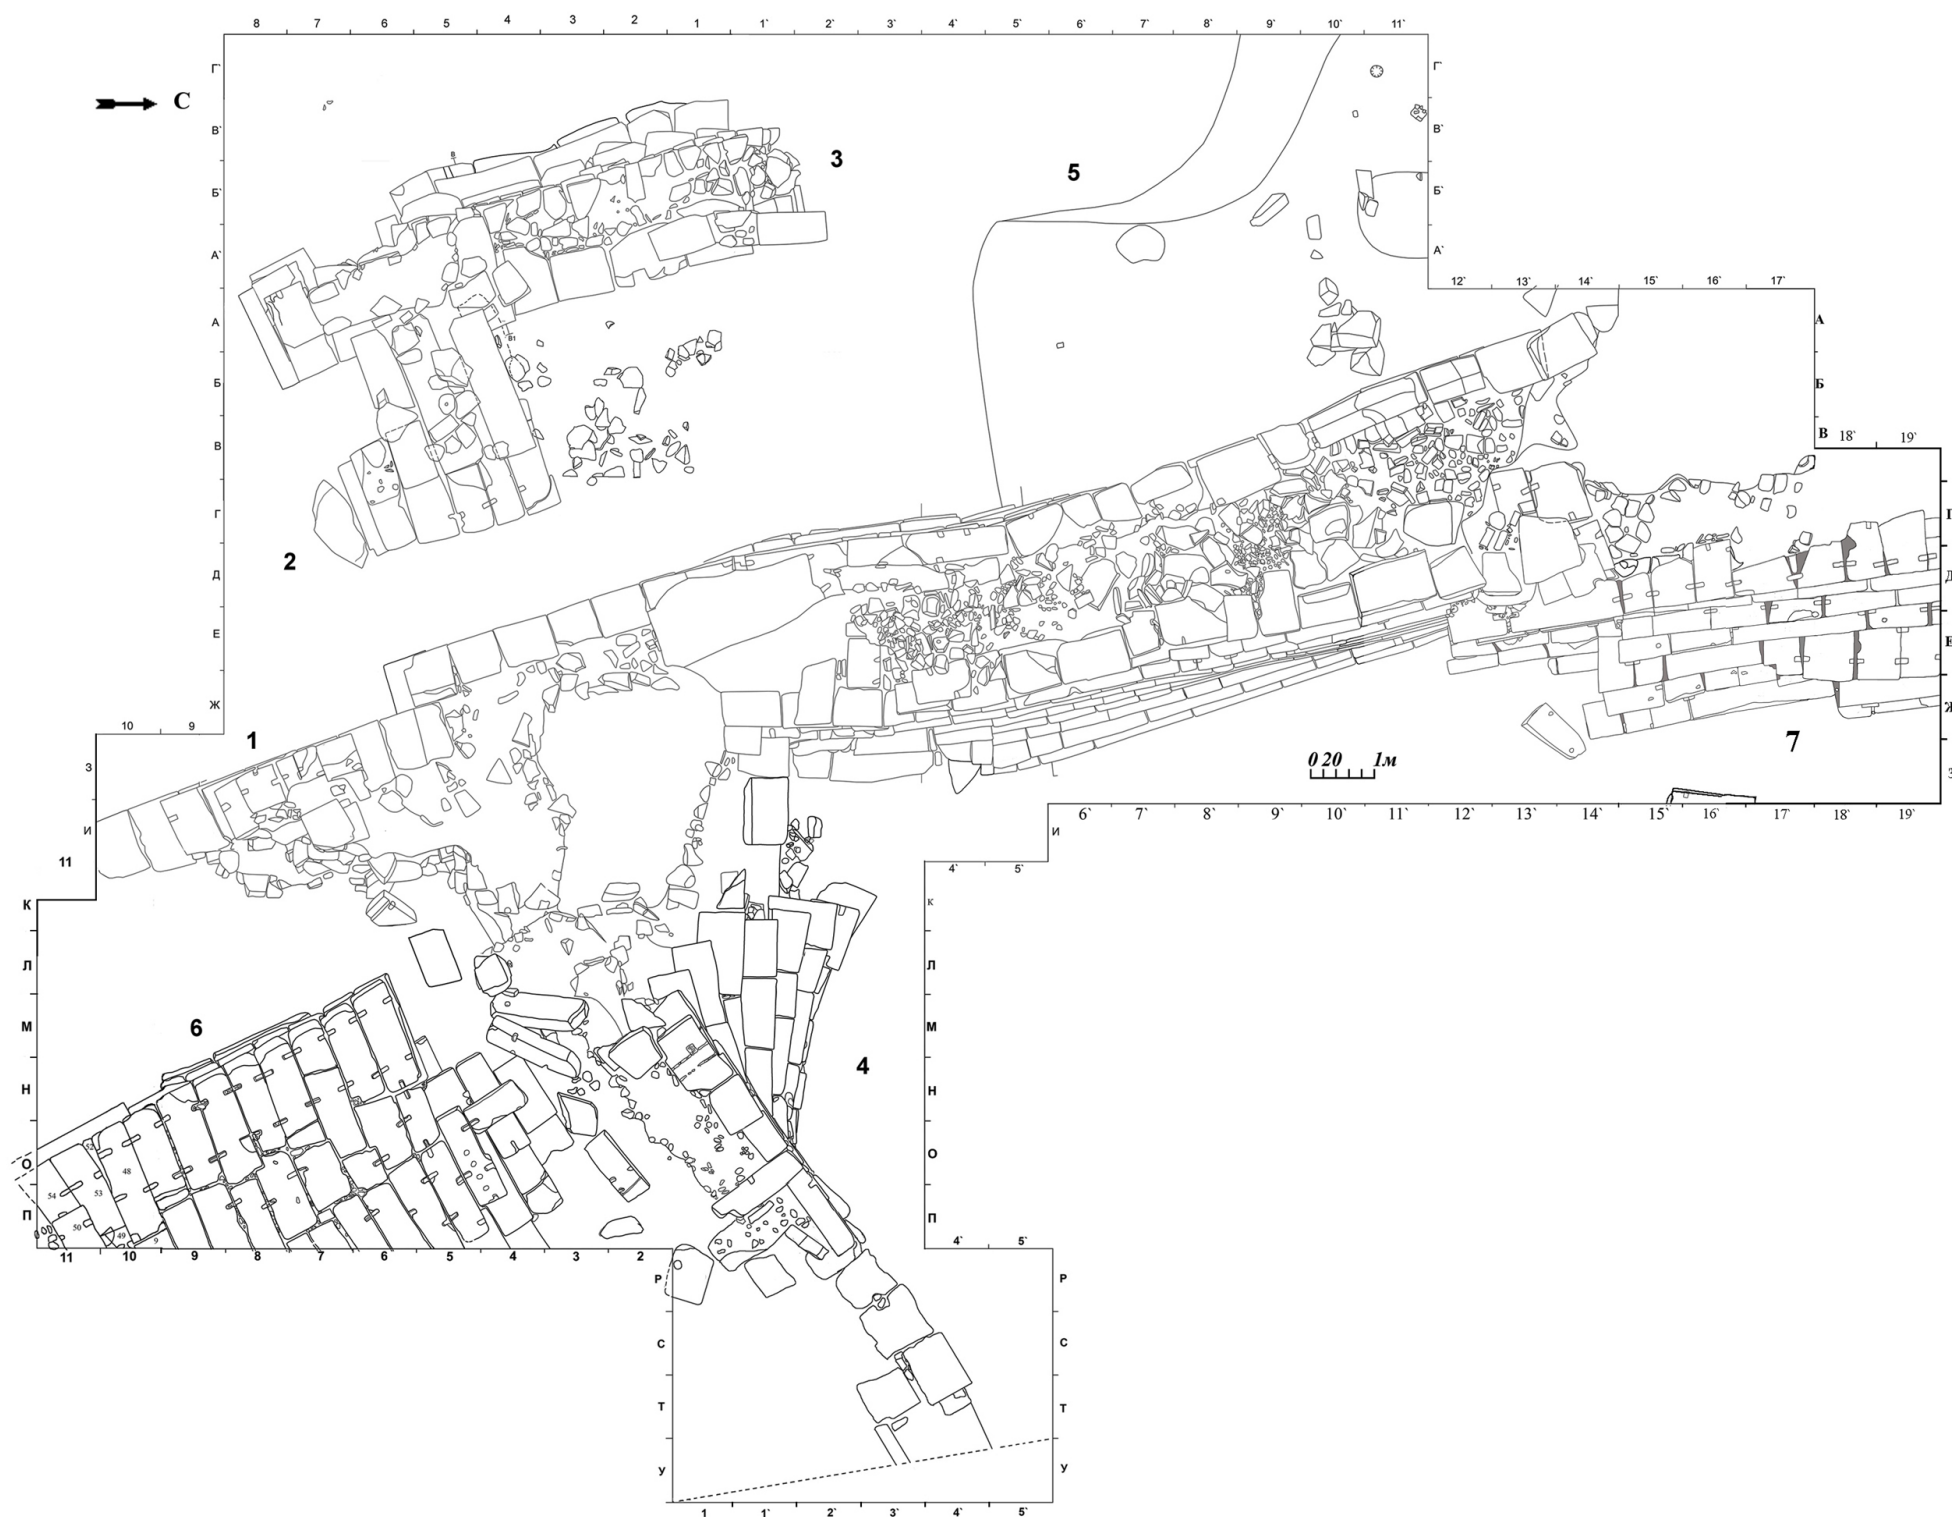
Fig. 2. Monumental architectural structure on river Rubas. Plan of the studied structures in 2022.
 1 – Wall No. 1; 2 – Arched Structure; 3 – Wall No. 1; 4 – Wall No. 3; 5 – mudflow deposits; 6 – Structure No. 5 (Platform); 7 – Structure No. 6 (Extension)

5. The observed stepped design in two structures, namely Structure No. 6, attached from the north to the eastern facade of Wall No. 2, and Wall No. 3 (Fig. 1, 4; 2; 2, 7, 4), raises questions. The northern facade of Wall No. 3 displayed not only a stepped design but also a fan-shaped (radial) arrangement of massive blocks. The functional rationale behind these intricate design techniques for these structures has not been conclusively identified.

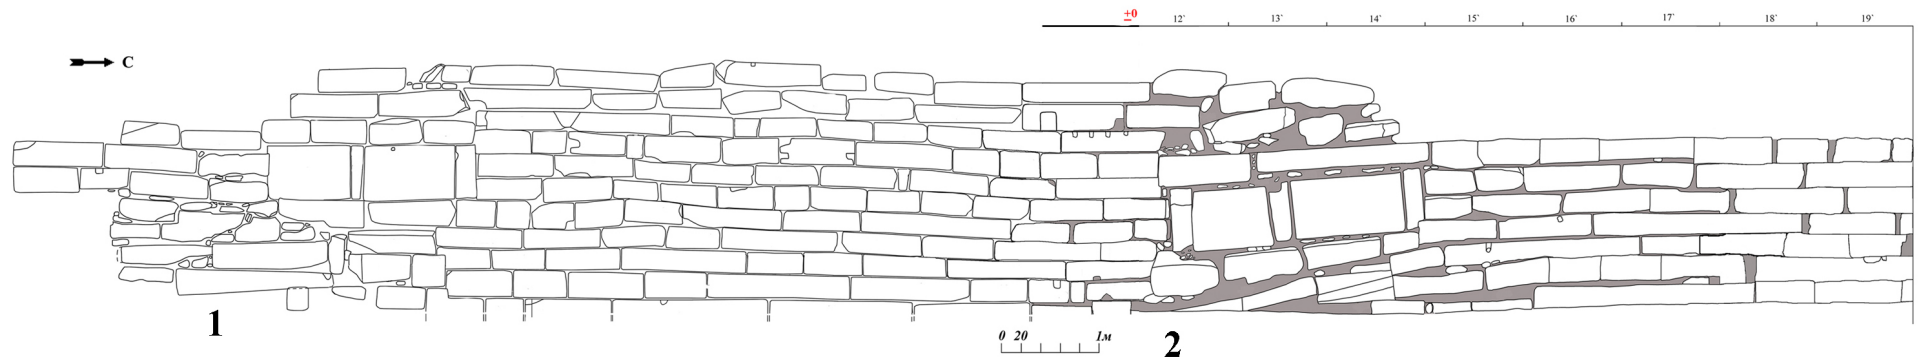
Fig. 3. Monumental architectural structure on river Rubas. 1 – eastern façade of Wall No. 2; 2 – Structure No. 6

Sections of the facades of Wall No. 2, constructed using *opus quadratum*, bore distinct signs of monumentality. On the western facade of Wall No. 2, a 6.0 m section was crafted using this technology, seamlessly connecting to stretcher bond sections from the south and north (Fig. 4). Similarly, the eastern facade of Wall No. 2 featured a 2.1 m section laid in *opus quadratum* (Fig. 3, 1), displaying thematic carvings on two front slabs (Fig. 7–8). A comparable 2.6 m section with finely processed slabs but lacking carved images was identified on the facade of the stepped Structure No. 6 (Fig. 3, 2).

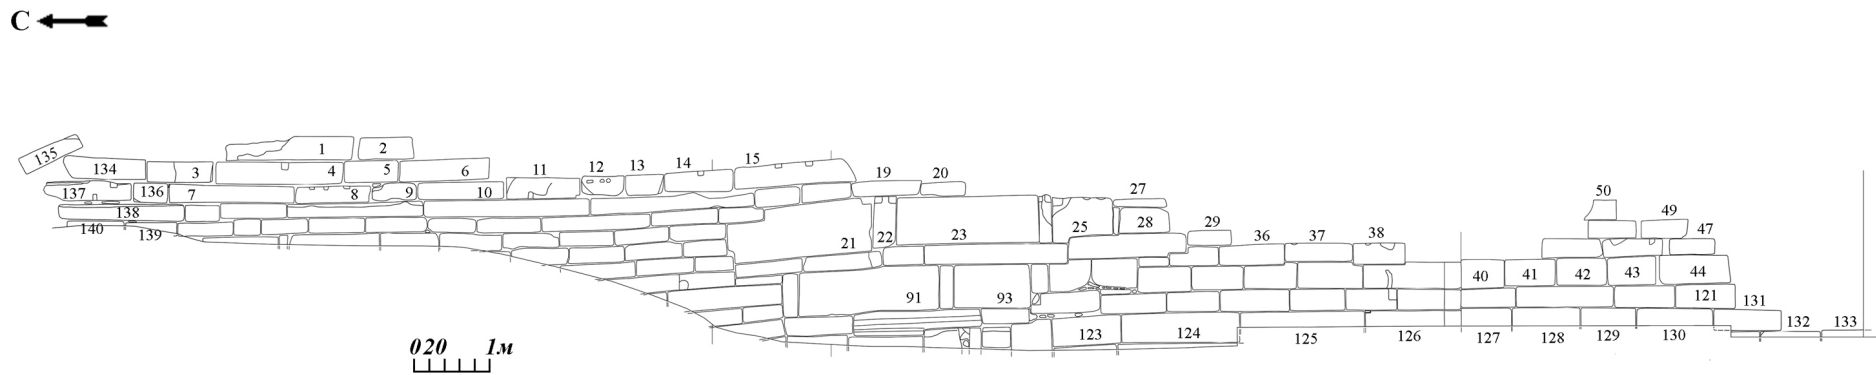
Fig. 4. Monumental architectural structure on river Rubas. Wall No. 2. Western façade. 2018

On the western facade of Wall No. 2, *opus quadratum* was incorporated in its middle section, extending for 5.8 m (Fig. 4). The distinctive feature of the design of this section of the western facade of Wall No. 2 is the utilization of two types of masonry during its construction -stretcher and *opus quadratum*. Stretcher masonry served as interlayers and covers between two rows of *opus quadratum* masonry. Researchers have observed that the masonry of the walls in Sasanian Derbent primarily consists of stone blocks with standard sizes, resembling medium-sized rectangular slabs [7, p. 31–43]. No large blocks similar to those installed in the western facade of Wall No. 2 in the Rubas architectural complex have been identified in Derbent. During the period of Arab Caliphate rule, medium-sized rectangular blocks were employed in the facades of Derbent walls, and these blocks differed from those of the Sasanian period in that they were more finely processed and nearly uniform in size. Considering the presence of very large blocks in the western facade of Wall No. 2 in the Rubas architectural complex (three stretcher blocks with lengths of 1.9 m, 1.9 m, and 1.86 m), which were not utilized in the defensive structures of Derbent, the dating of the complex on the river Rubas has been attributed to an earlier period (mid-6th century) than Derbent.

manner. The upper and lower rows of masonry follow the *opus quadratum* technique, separated by a single row of stretcher masonry, where the blocks are laid flat. The same blocks in one row serve as a covering for the upper level of *opus quadratum* masonry. Additionally, these blocks form the base for the second row of *opus quadratum* masonry (Fig. 4).

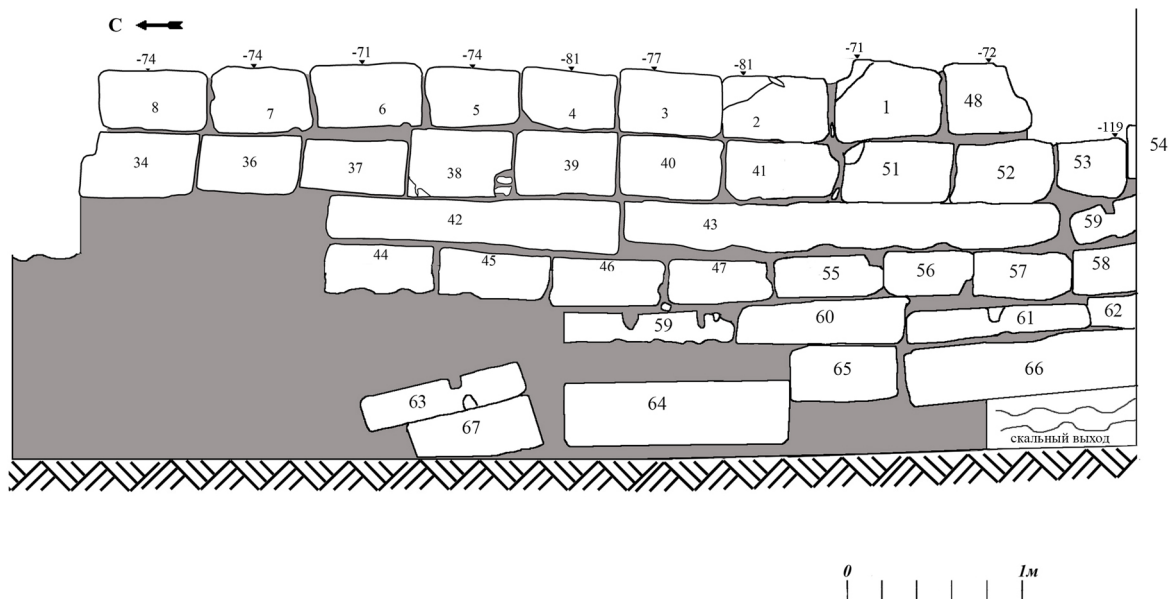
Fig. 5. Monumental architectural structure on river Rubas. Structure No. 5 (Platform). Western façade with indication of Nos. of blocks and sections. 2022

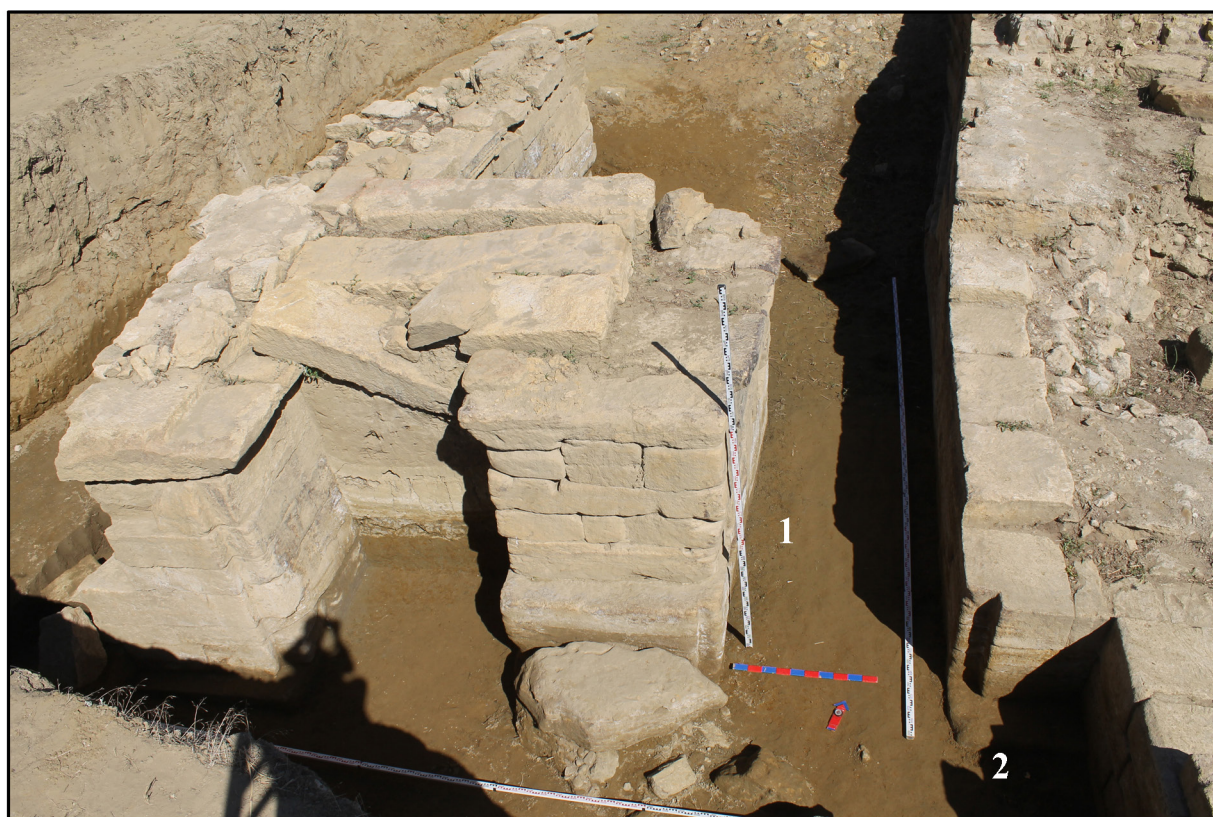
Fig. 6. Monumental architectural structure on river Rubas. 1 – Arched Structure; 2 – Wall No. 2. View from south. 2020

Between the western facade of Wall No. 2 and the arched structure there was another passage, equal in width to the former (1.5 m) (Fig. 6).

It is assumed that Arched Passage No. 2 was obstructed by a gate, secured by a block (distinct grooves for installing a gate blocker were identified). An investigation of the passage between the support bases of the arched structure was not possible due to its filling with mudflow deposits (Fig. 6). It is conceivable that these passages might have incorporated protective barriers implemented through an ancient cataract system involving movable barriers. Within the masonry of the western facade of Wall No. 2 and the base of Support No. 1 of the arched structure, vertical recesses (with heights of 1.0 m and 1.9 m) were observed, presumably designed for the movement of protective devices. Additionally, massive slabs at the base of the structures were identified, possibly intended for securing lowered protective devices (Fig. 6).

remained accessible to potential adversaries (Fig. 6, 1). A similar scenario was observed in the vicinity of another passage located between the western facade of Wall No. 2 and Support Base No. 1 of the Arched Structure. Although the four slabs covering this passage have not survived, their former installation points are indicated. The upper level of the western facade of Wall No. 2 at the location of Passage No. 2 has not been preserved, but a small section of a 1.0 m high gutter for installing a protective device was identified at the bottom of this facade (Fig. 6, 2).

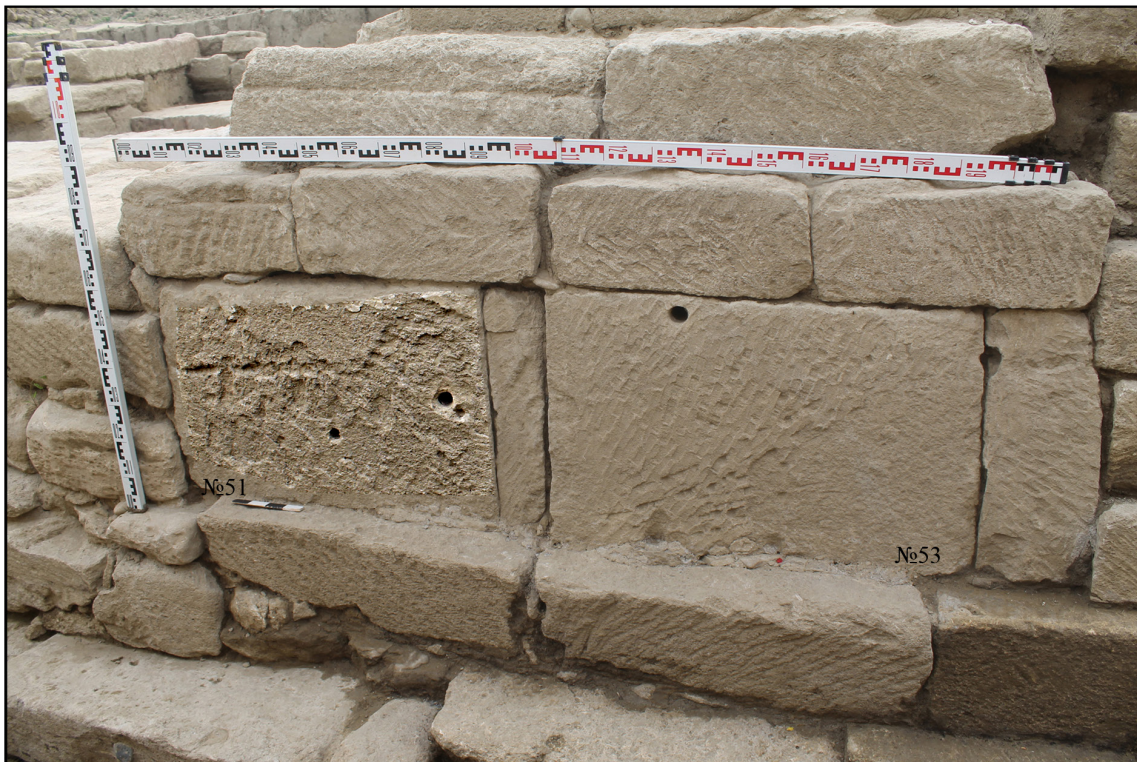
Fig. 7. Monumental architectural structure on river Rubas.
Structure No. 2. Eastern façade. Blocks Nos. 51-53. View from east

As mentioned, on the surface of one of the slabs there is a relief image of a horse, with its head directed north, towards Derbent, and also, possibly, a rider (Fig. 7). This image could symbolize the collective representation of an Arab warrior who played a role in the conquest of the formidable fortress city. A second slab also features a carved image, reminiscent, in our interpretation, of the layout of the structure erected on the river Rubas. In the upper

corner zone of the slab, a cluster of relief notches of a narrow rectangular shape is intricately arranged. This cluster is enclosed by a double dotted line with an arcuate shape, dividing the surface diagonally from the lower left to the upper right corner. The lower corner area of the slab appears to have been deliberately smoothed (Fig. 7-8).

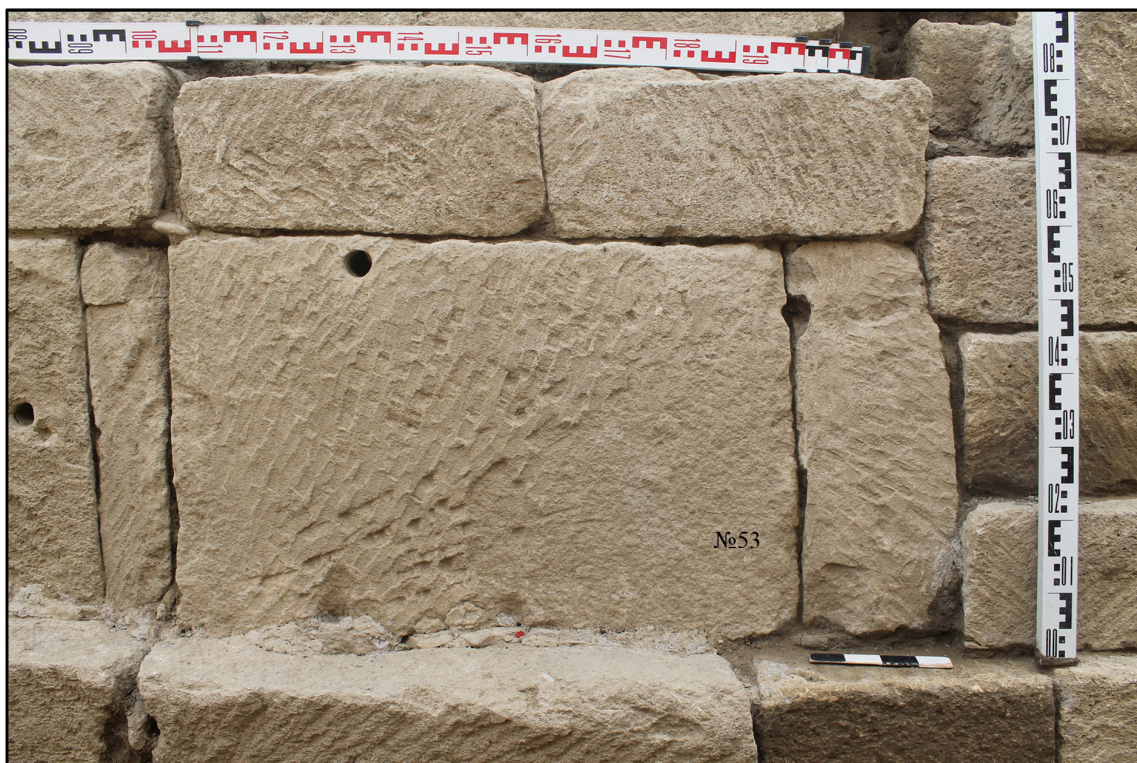
Fig. 8. Monumental architectural structure on river Rubas.
Structure No. 2. Eastern façade. Block No. 53. View from east.
